REFERENCENIST
PUBLICATIONS**NBSIR 85-3158**

Fire Performance of Interstitial Space Construction System

J. Randall Lawson

May 1985

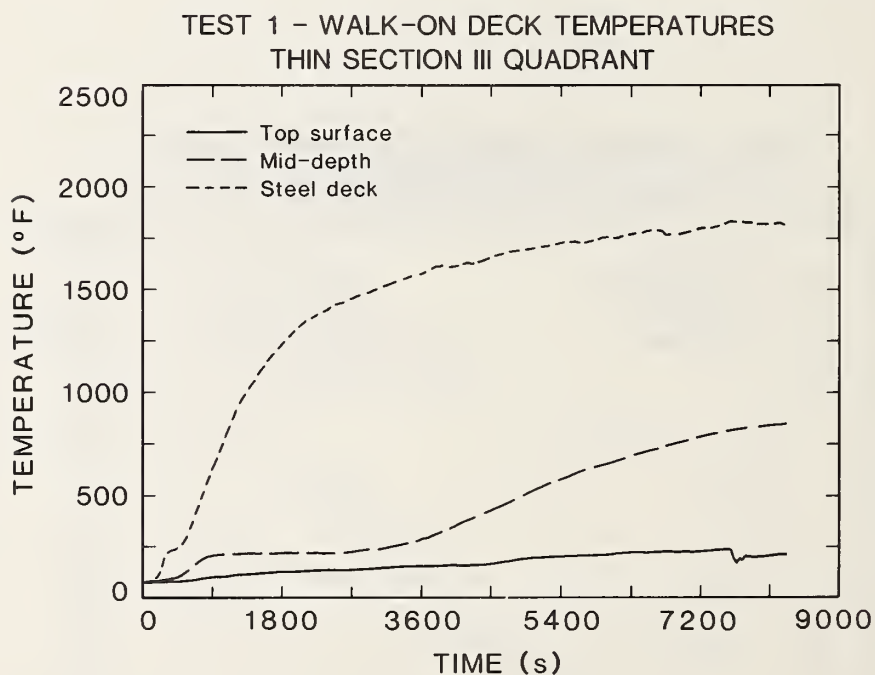
Figure 45. Walk-on deck temperatures thick section quadrant III, test 1

Figures 43 to 46 shows a comparison of walk-on deck temperatures. The high temperatures noted in figure 44 resulted from a crack developing in the walk-on deck near the measurement location. Temperatures were high enough to easily ignite cotton waste, as referenced in NFPA 251. Figures 45 and 46 show temperature rise data for a floor area that did not exhibit major cracking. In this case the surface temperatures stayed below 250°F.

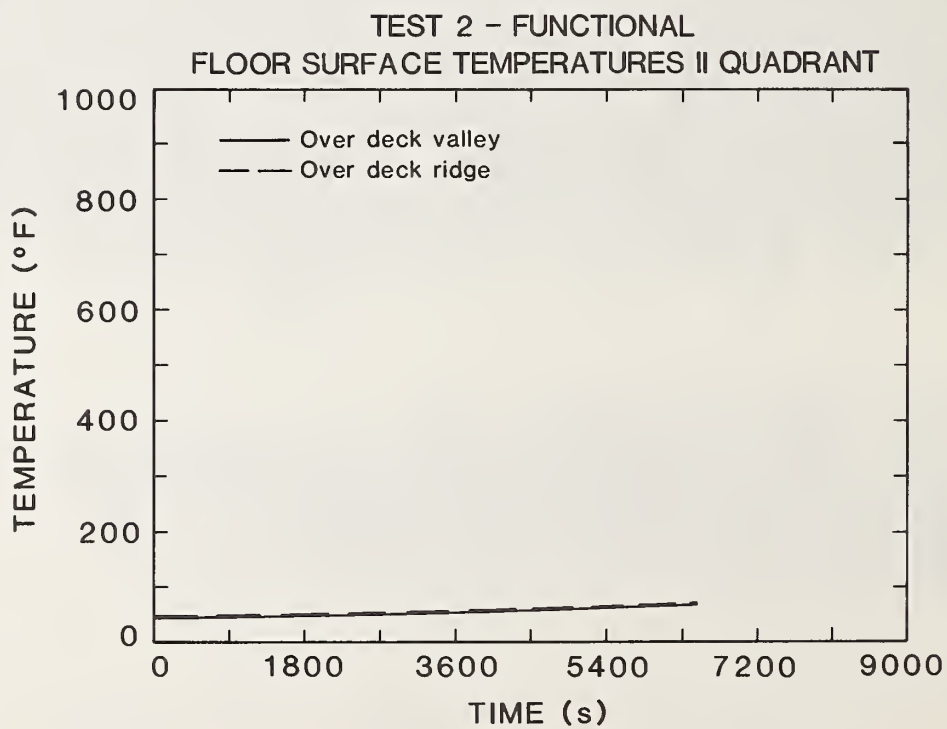
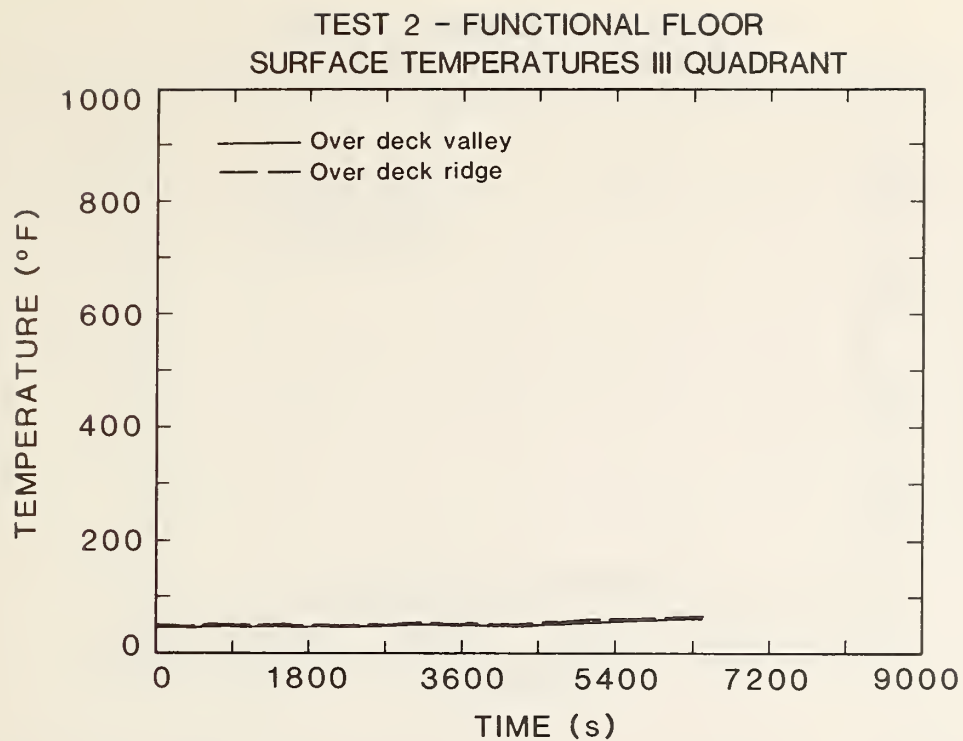
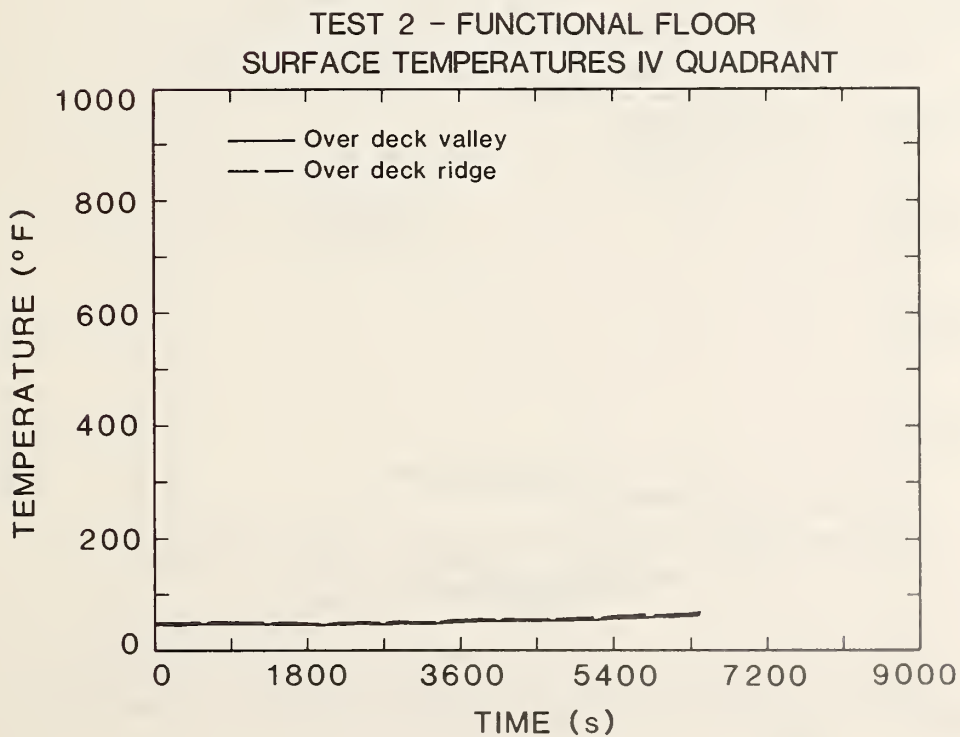
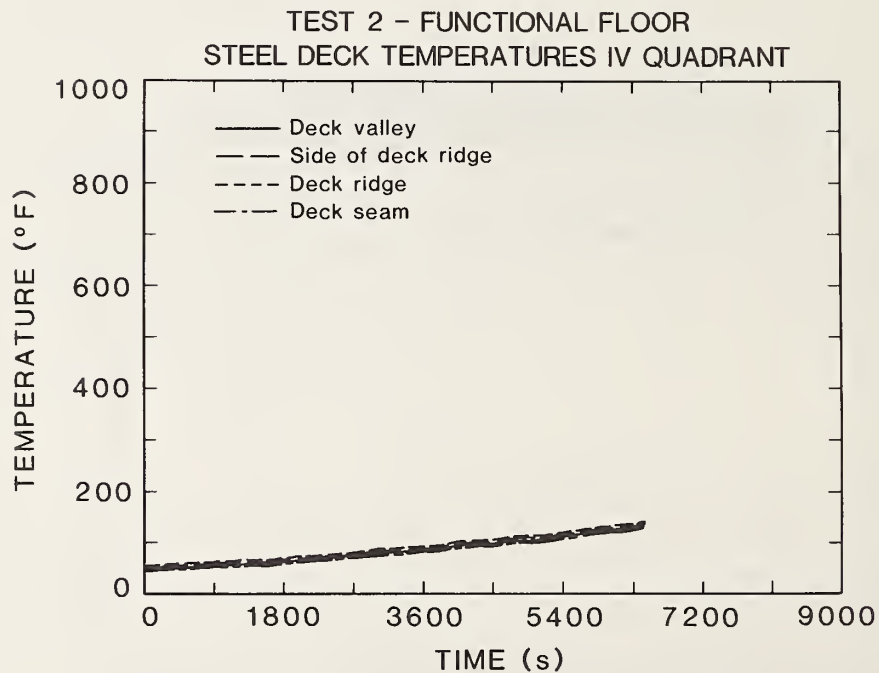
Data representative of the functional floor surface temperatures recorded during test 2 are shown in figures 54 to 58. The surface temperature from this test never exceeded 77°F. This was also well below the failure point of 250°F. The cooler surface temperatures in this test reflected the cooler weather experienced during test 1, see table 2. The steel deck temperature reached a peak of 138°F by the test's end, figure 59. The center beam supporting the function floor reached a peak temperature of 153°F, figures 60 and 61. The maximum temperature reached by the unprotected portion of the center column in the interstitial space was 165°F, figures 62 and 63. Figures 64 to 67 present plots of temperatures for the protected center column

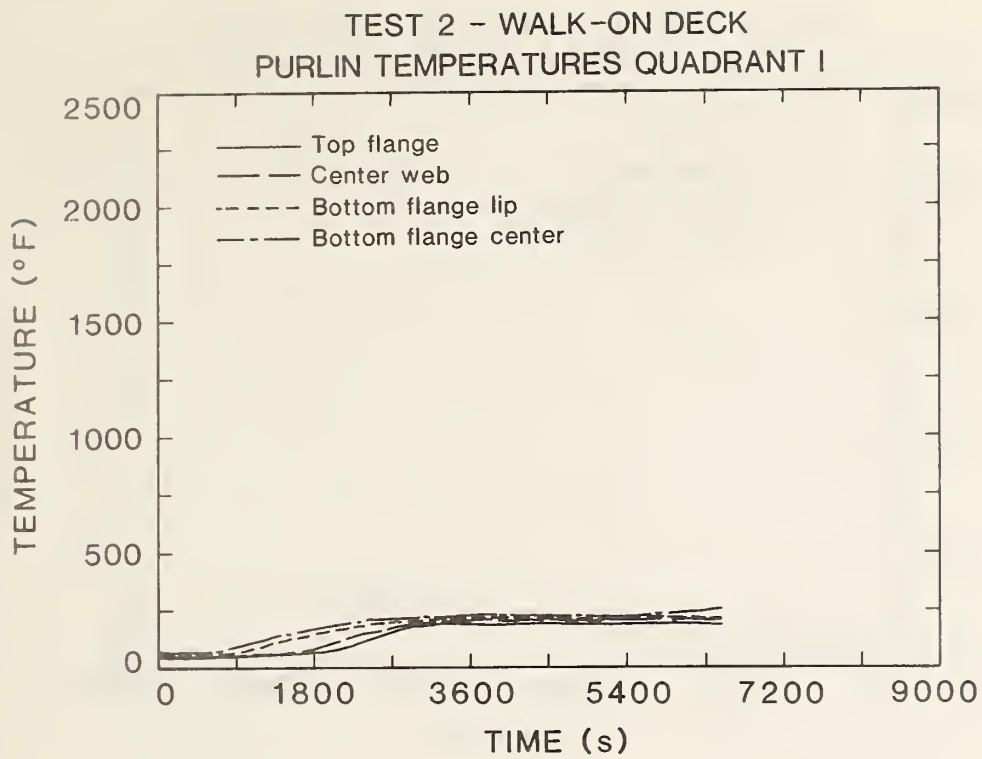
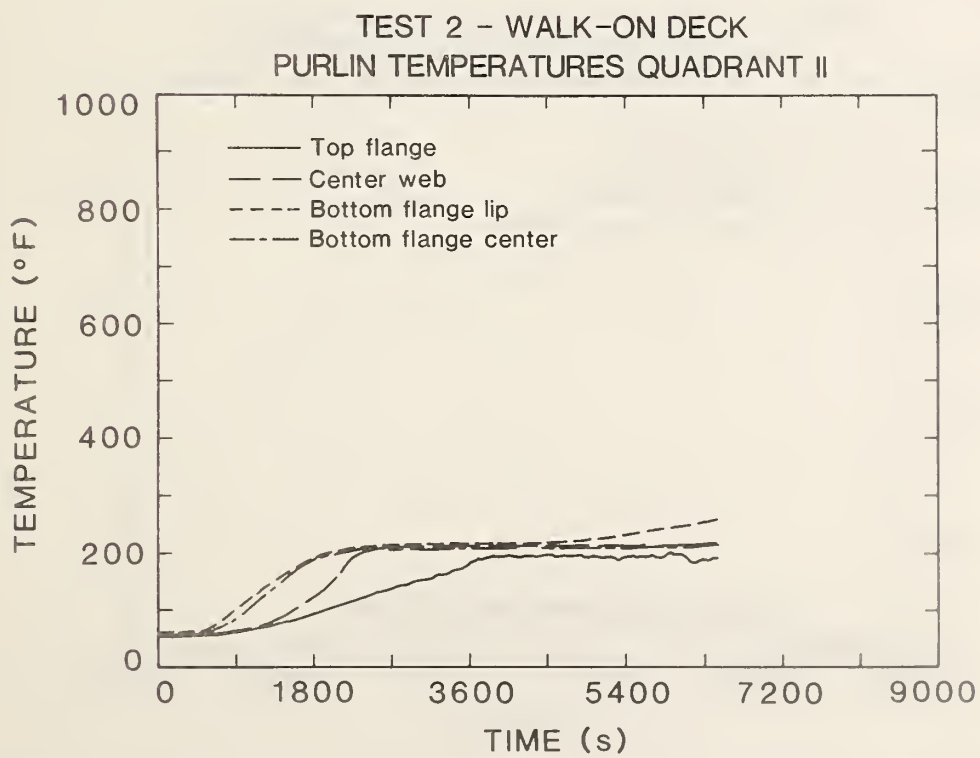
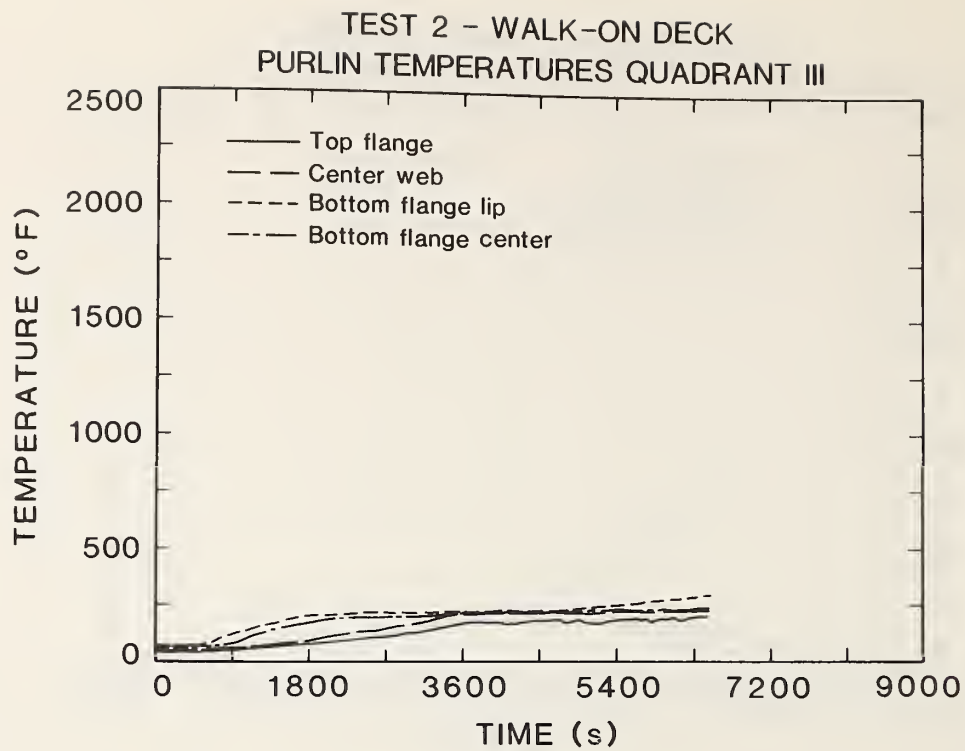
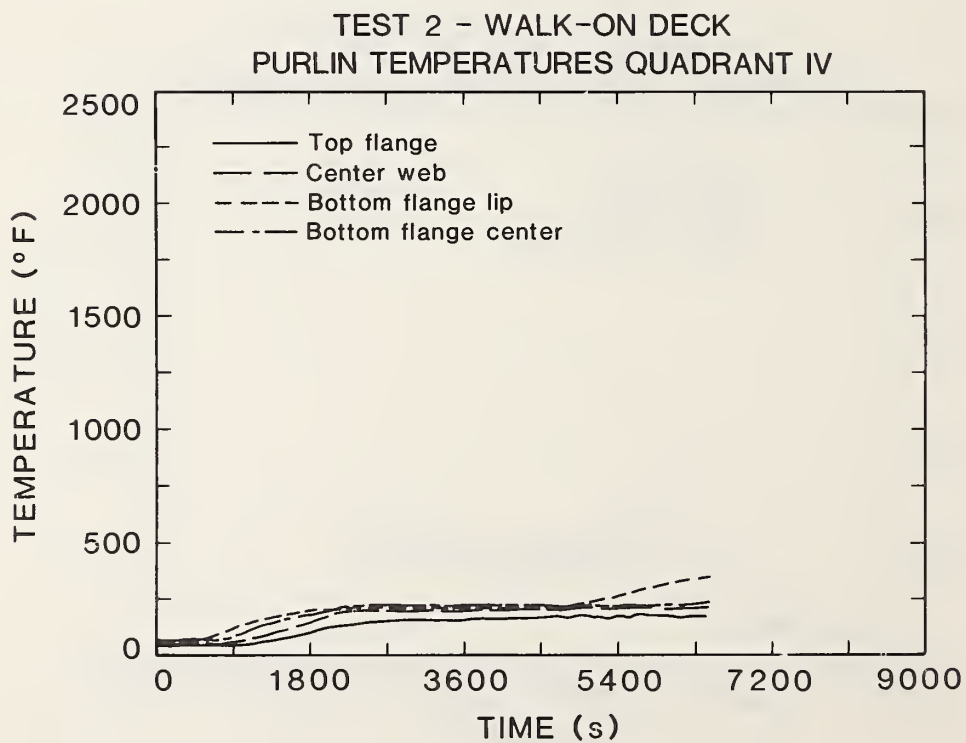
section that was exposed to the fire compartment. The maximum test temperature for the column was 937°F, and it occurred 18 minutes after the furnace burner was turned off. The fireproofed purlins supporting the walk-on deck performed well, figures 68 to 71. As stated in section 5.2.2, all fireproofing stayed on the purlins. This resulted in a maximum purlin temperature for this short test of only 354°F, figure 71. The walk-on deck temperatures are shown in figures 72 to 75. These temperature plots show similarity with the data obtained in test 1. The maximum surface temperature measured was 205°F. This again occurred after the burner was turned off, but the overall floor performance is much like that seen in test 1. Temperature plots for the walk-on deck suspension rods and steel tube bracket are shown in figure 76. Heat transfer through the purlins and the suspension system was clearly reduced as a result of the fireproofing remaining in place. The temperature of these structural elements remained significantly low throughout the test exposure. Figures 77 and 78 provide information on duct temperatures and air temperatures in the interstitial space. Again, these temperature plots show similar performance to that experienced with the first test. However, a major difference is seen in figure 79 when compared with figure 49 of test 1. Test 2 shows very little movement in purlin deflection measurements. Since the purlins and walk-on deck system of test 2 appeared to maintain much of their initial strength after this aborted test, it was decided to conduct another full two hour test on the same assembly in an attempt to obtain additional information. Only the fire protection on the column and pier was replaced.

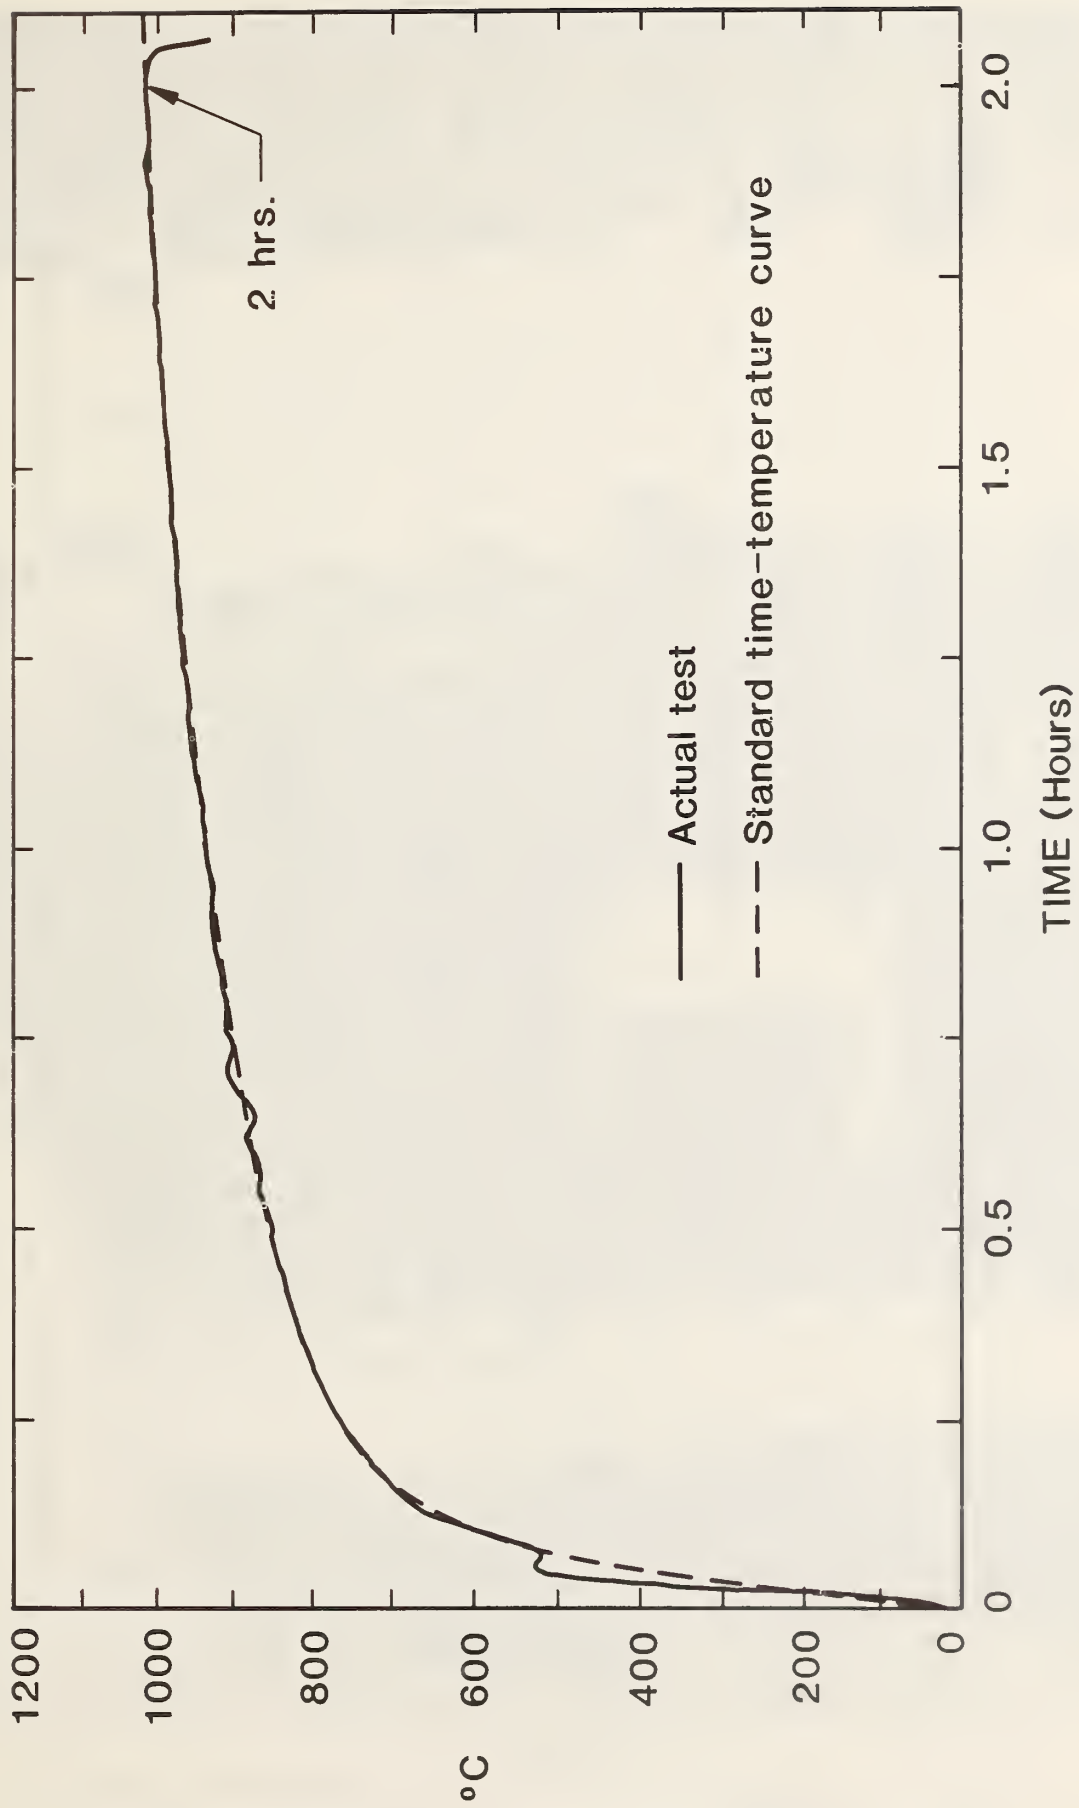
Figure 80. Chart record of average furnace temperature, test 2A

The record showing the average furnace temperature throughout the two hour test is presented in figure 80. It should be noted that the assembly exposed to this standard fire test was the same assembly tested for 1.5 hours the day before. This should be kept in mind when comparing test results. The gypsum board protection on the column and pier was replaced for test 2A.

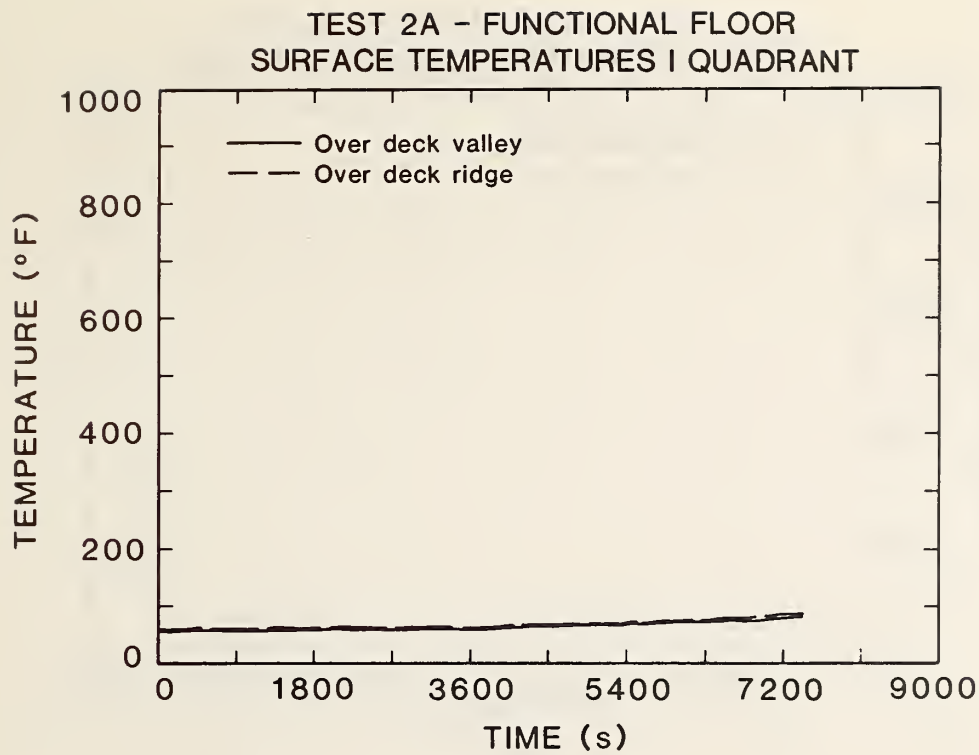
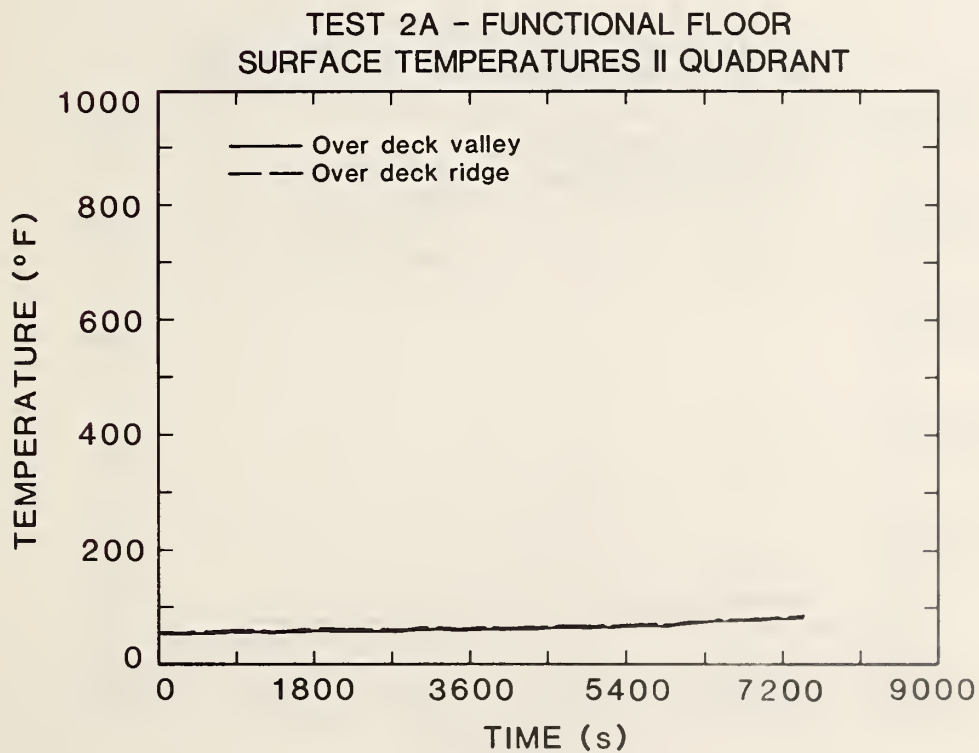
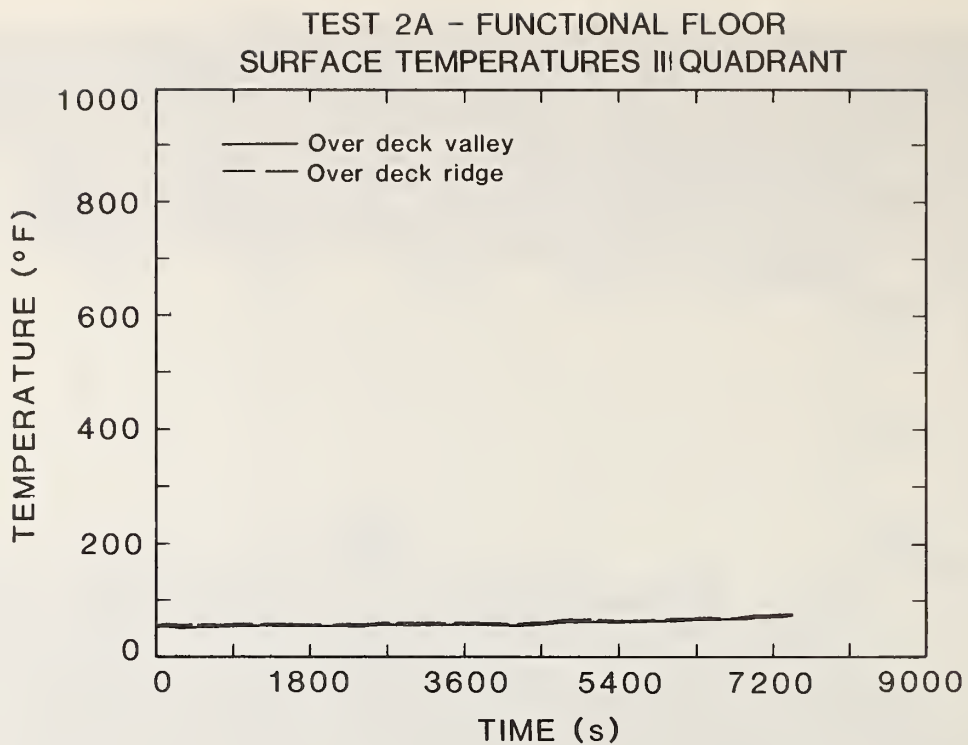
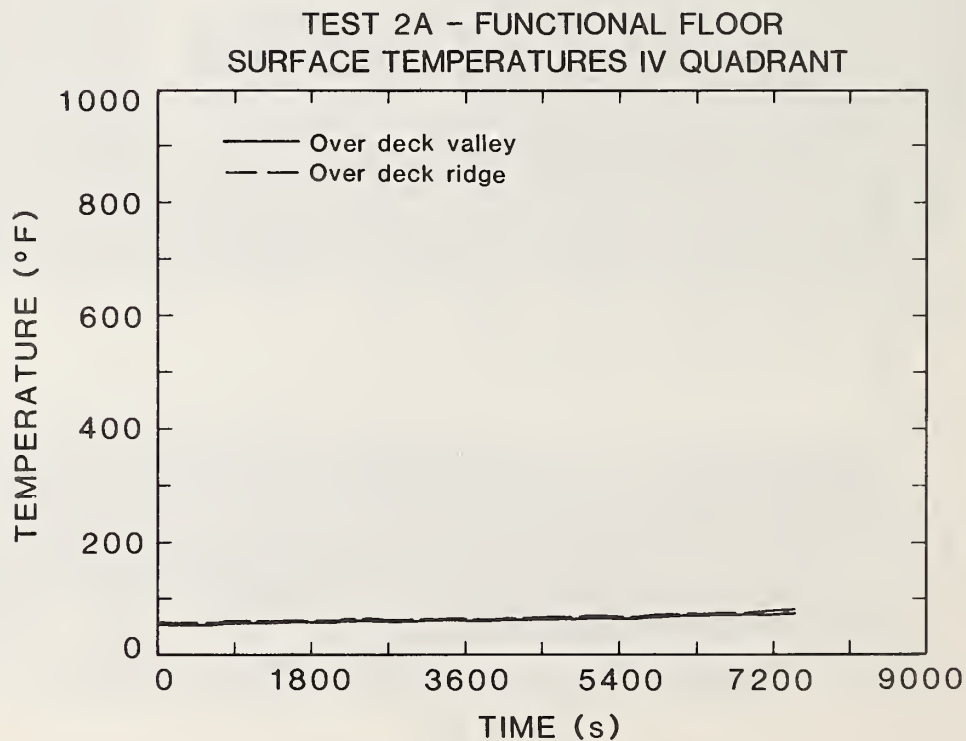
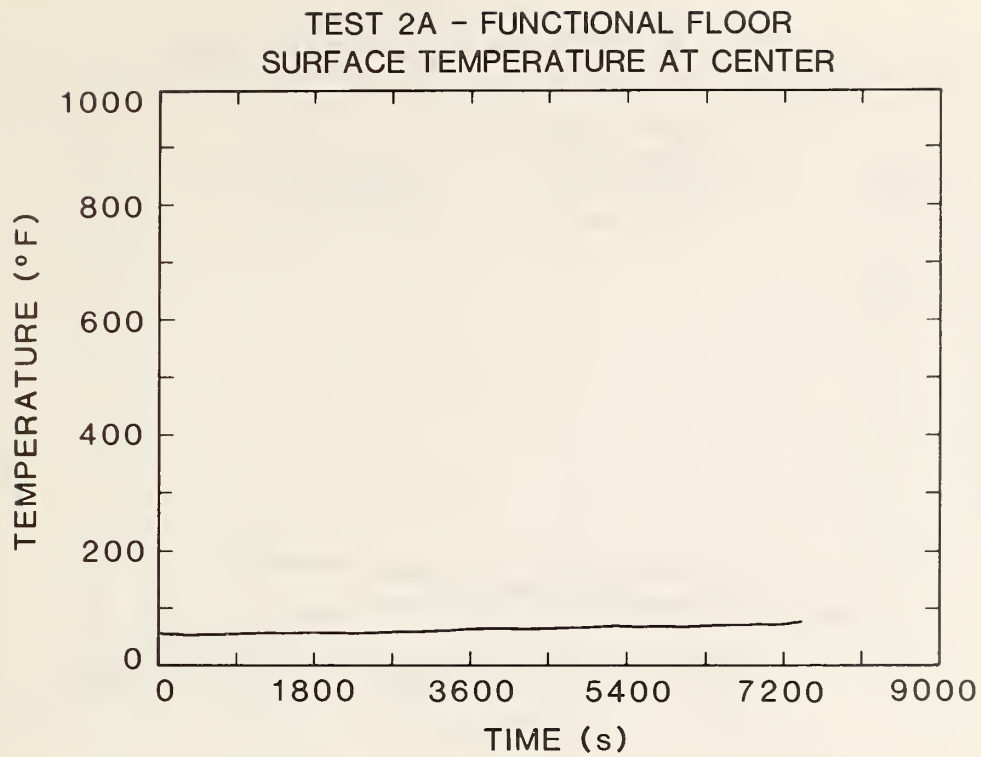
Heat transmission through the functional floor during the second exposure of the test assembly was limited, figures 82 to 86. The maximum temperature on the unexposed surface of the functional floor was 88°F. The steel deck supporting the floor experienced a maximum temperature of 156°F which was 18°F more than that during test 2, figure 87. In addition, the center beam supporting the walk-on deck also showed higher temperatures than recorded in tests 1 or 2, figures 88 and 89. The maximum temperature in this test for the beams was 201°F. The center column in the interstitial space also performed well during this second exposure, figures 90 and 91. It should be remembered that the gypsum board system protecting the center column in the fire compartment was completely rebuilt for test 2A. As seen in figures 92 to 95, the column did not remain adequately protected in the fire compartment. A

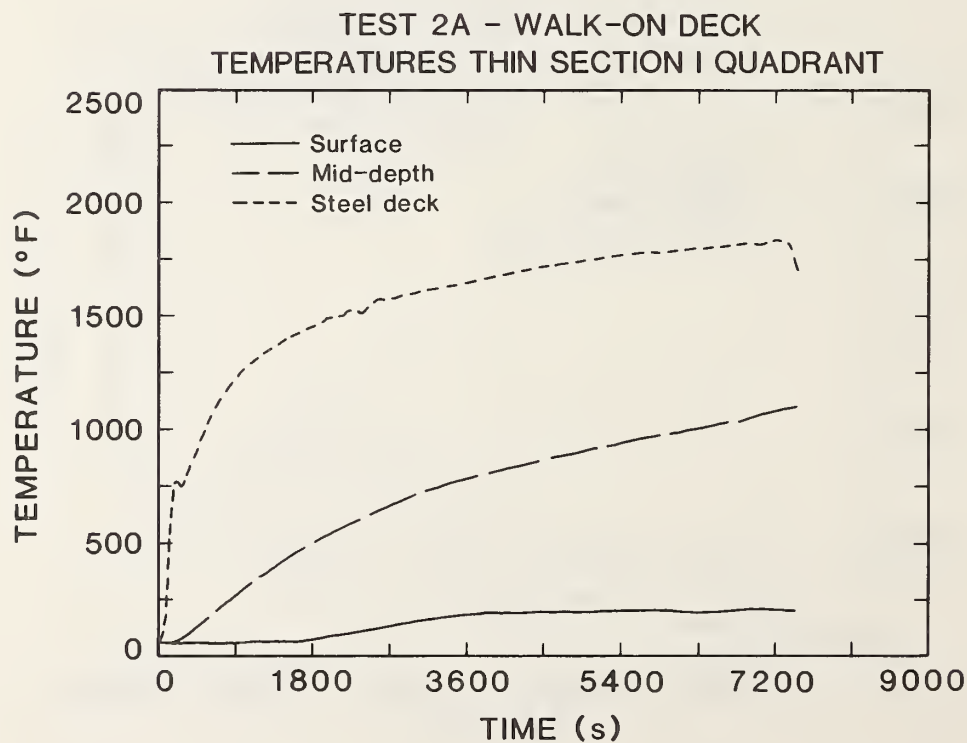
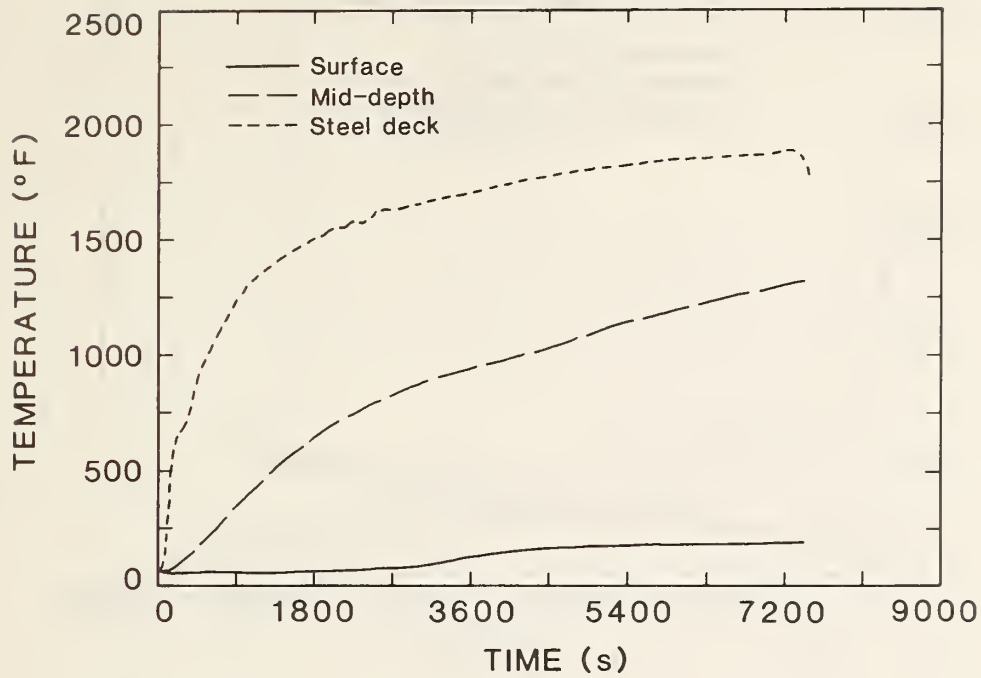
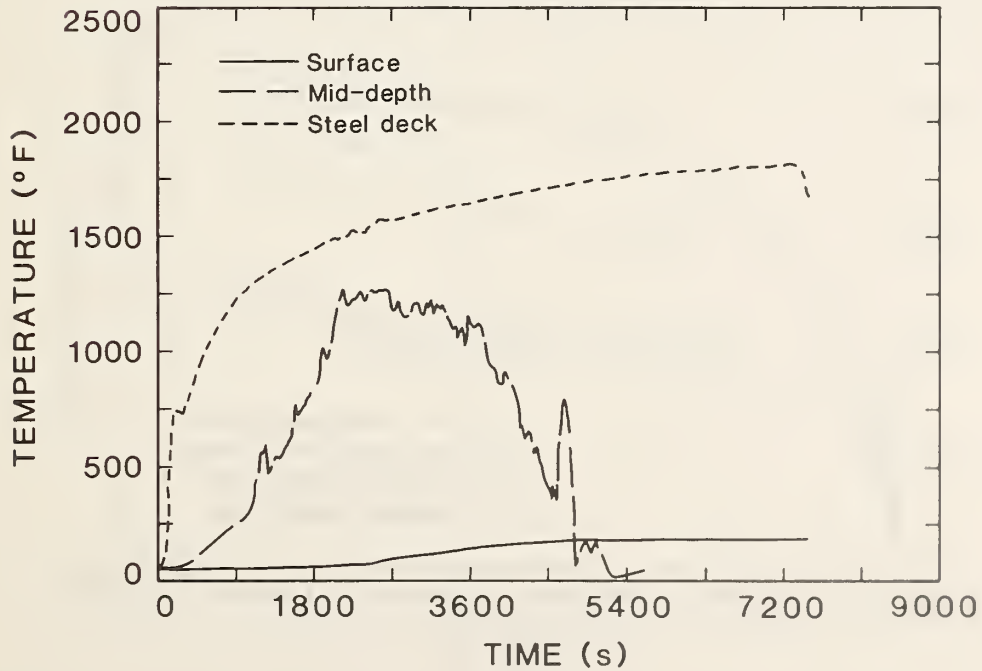
The walk-on deck during this test generally performed better than the walk-on deck in test 1, figures 100 to 103. This deck did not show the amount of cracking noted at the end of test 1. The suspension rod and steel tube bracket temperatures are presented in figure 104. Temperatures recorded for the dummy air conditioning ducts, figure 105, are similar to results obtained during tests 1 and 2. Air temperature in the interstitial space reached a maximum of 331°F. This is only 36 degrees higher than that experienced in test 1. Particular attention was paid to the purlin deflections recorded during this test, figure 107. In test 1, the deflections were random, and in test 2 the purlins moved very little. During this test the purlins showed a gradual movement in the downward direction. This movement was attributed in part to the gradual degradation of the fireproofing combined with the

Figure 101. Walk-on deck temperatures thin section quadrant I, test 2A

Figure 102. Walk-on deck temperatures thick section quadrant III, test 2A

Figure 103. Walk-on deck temperatures thin section quadrant III, test 2A

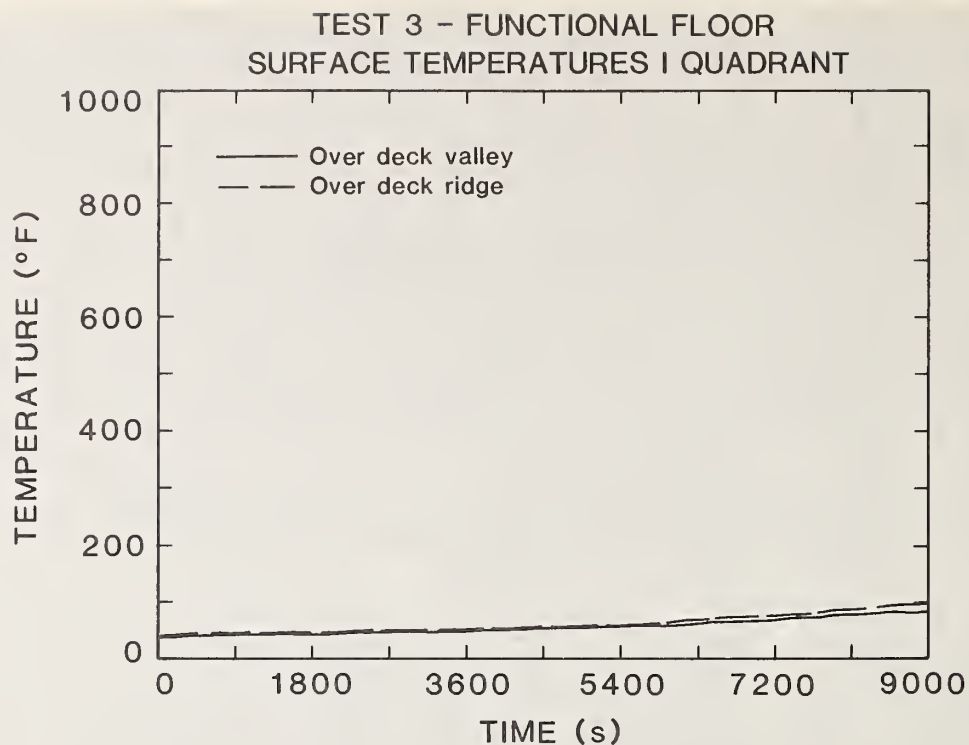
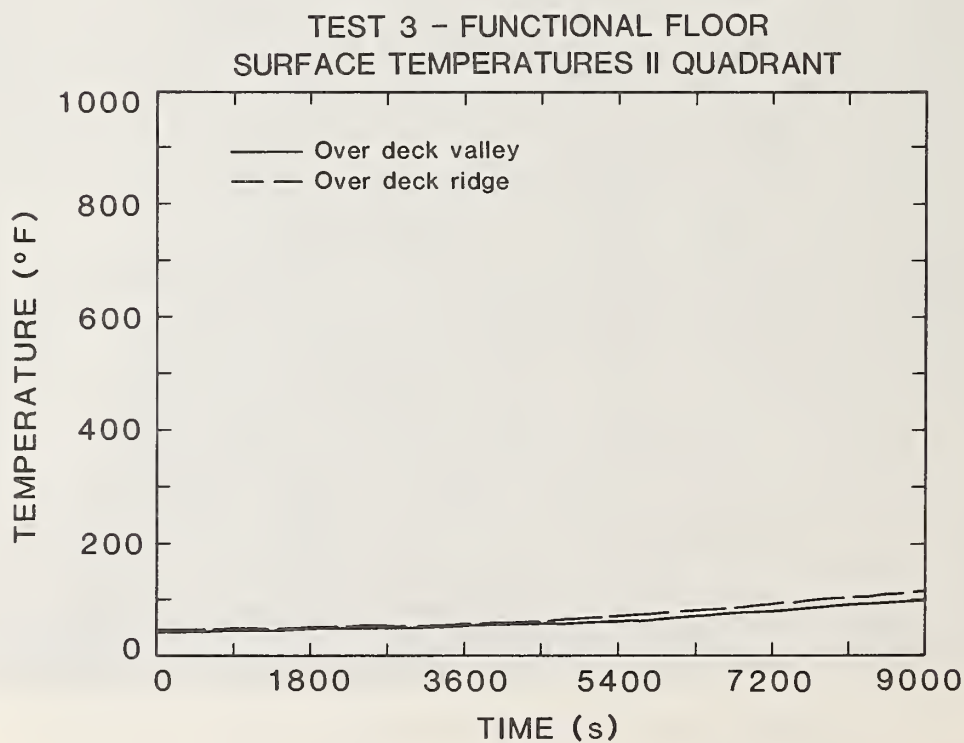
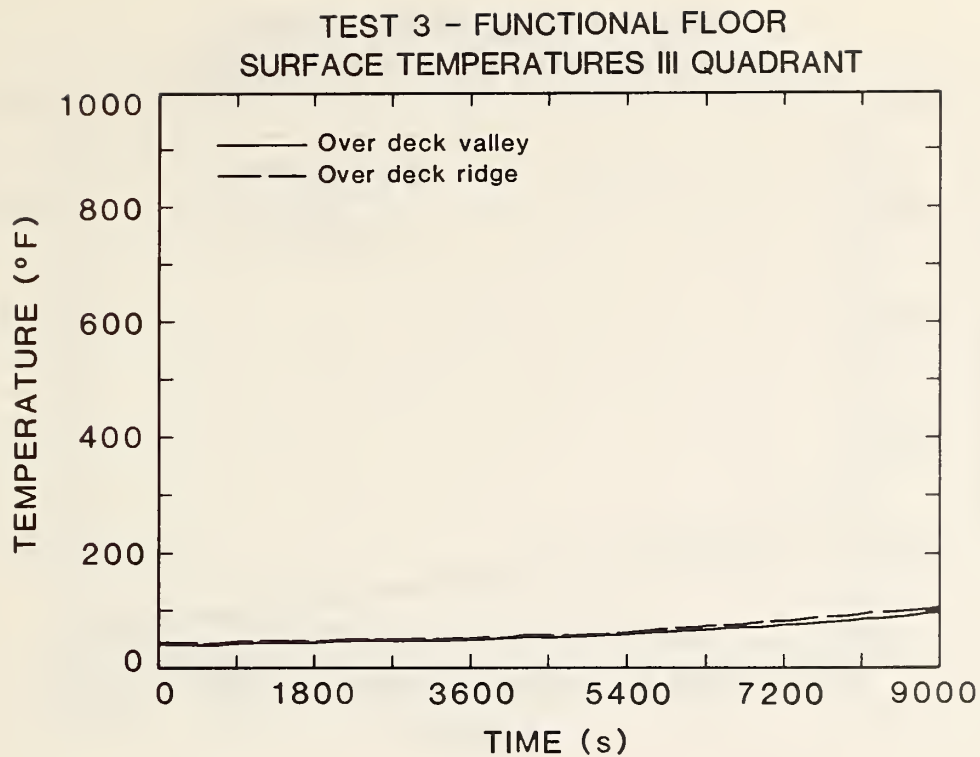
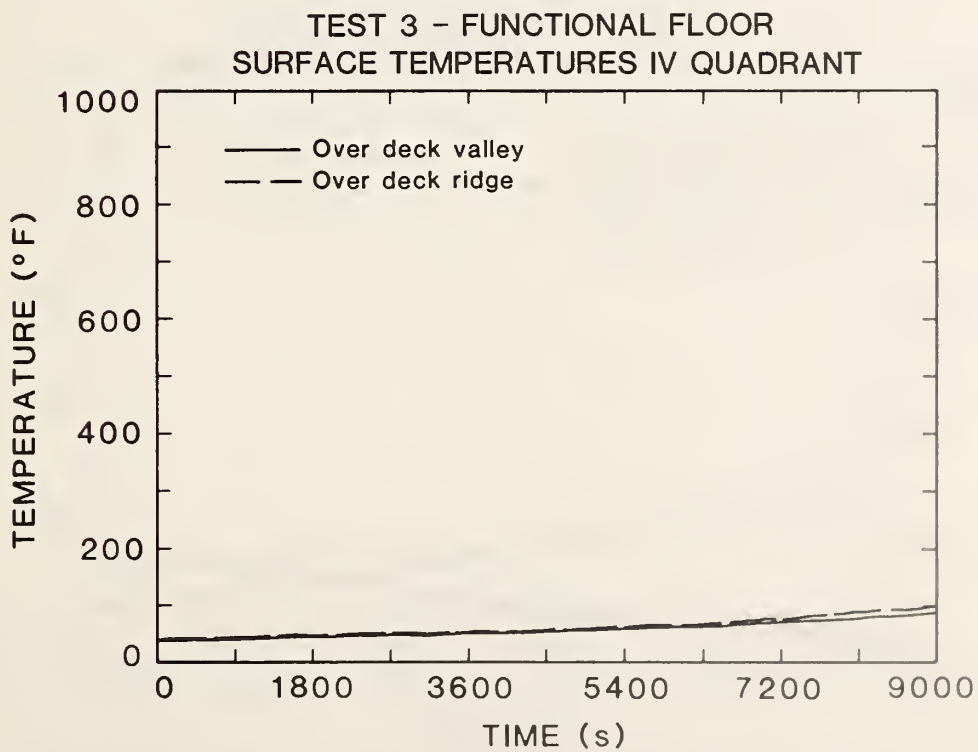
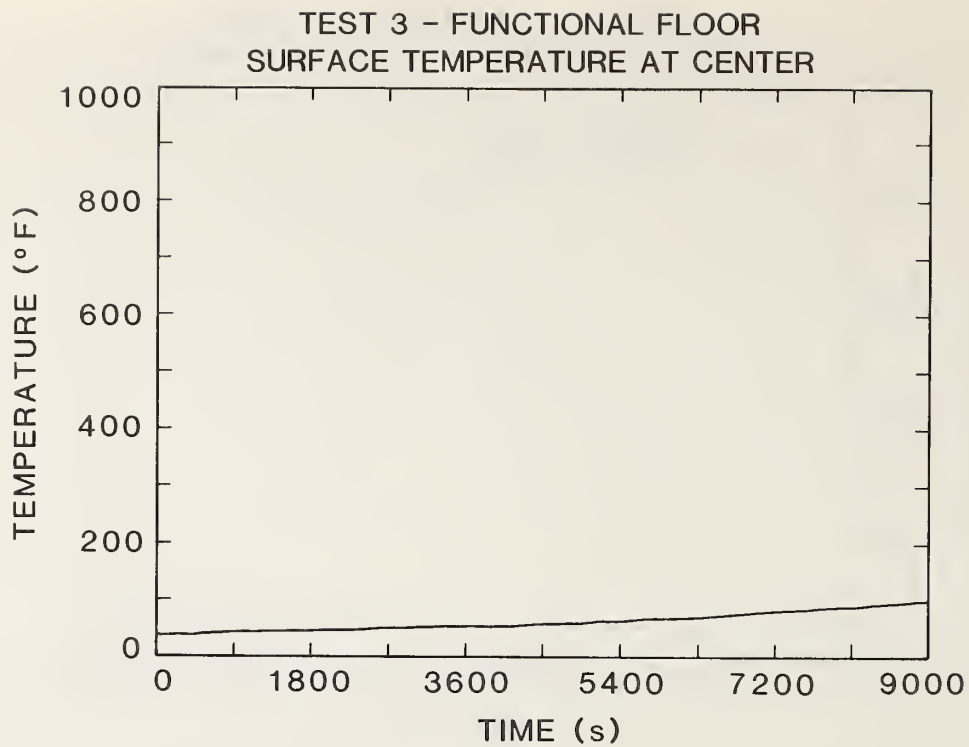
In test 3, the functional floor temperatures showed that the walk-on deck provided significant resistance to heat flow. Figures 114 through 118 show that the maximum temperature on the top functional floor surface never exceeded 115°F during the 2.5 hour exposure. The temperature of the steel deck supporting the functional floor had a maximum temperature of 176°F, figure 119. This temperature was less than that measured in test 1, but was more than 35°F higher than the maximum steel deck temperatures measured in tests 2 and 2A. These maximum deck temperatures are still well below any critical temperatures specified by the test procedure. Temperatures for the central beam supporting the functional floor are shown in figures 120 and 121. The highest temperature measured was 304°F which is substantially below the critical temperature for that structural element. This temperature was measured after 2.5 hours of test exposure. The unprotected column in the

Figure 114. Functional floor surface temperatures quadrant I, test 3

Figure 115. Functional floor surface temperatures quadrant II, test 3

Figure 116. Functional floor surface temperatures quadrant III, test 3

Figure 117. Functional floor surface temperatures quadrant IV, test 3

Figure 118. Functional floor surface temperature center of test bay, test 3

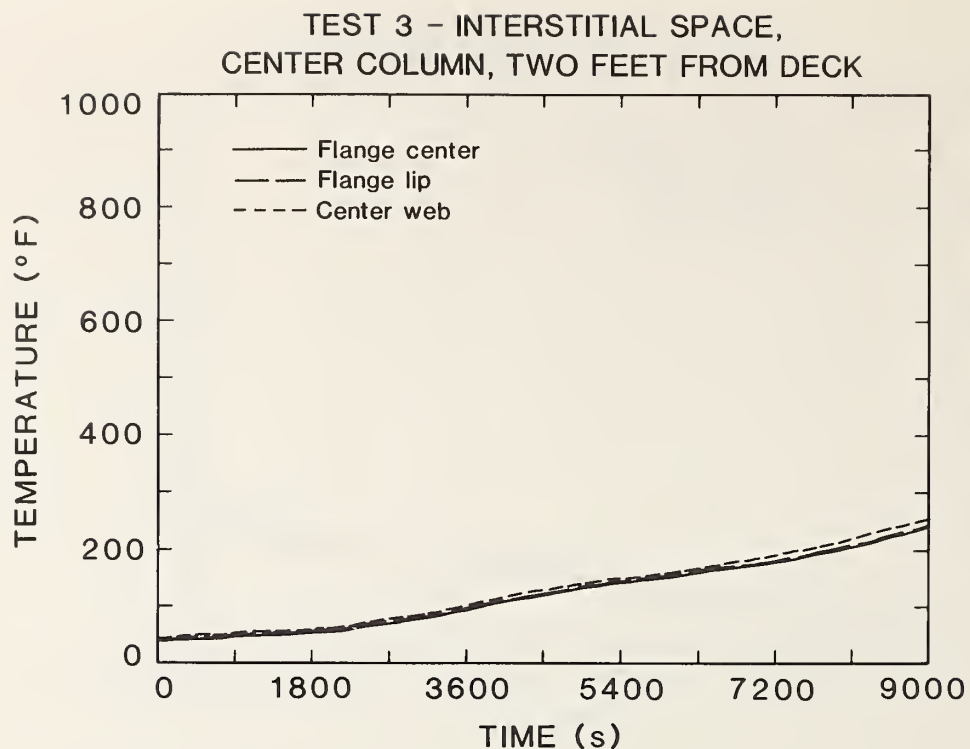
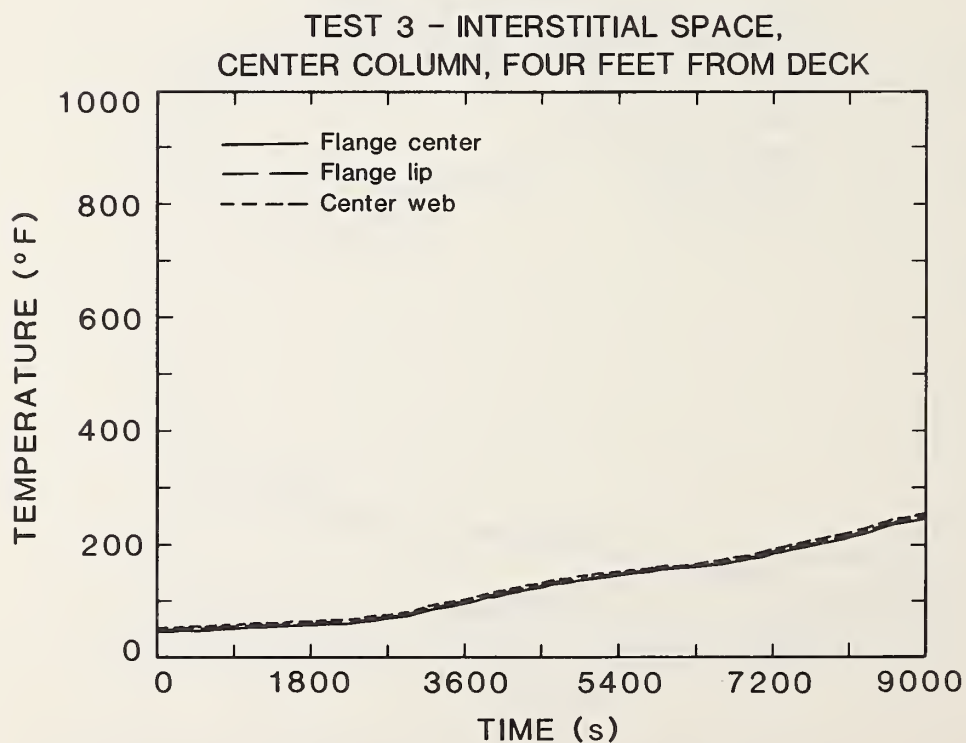
interstitial space also showed relatively low maximum temperatures, figures 122 and 123. In figure 123, the measurement made at the column flange lip was discarded because of a thermocouple failure. The flange and web temperatures show similar results with measurements well below the critical 1200°F value. The protected part of the center column also performed well in this test, figures 124 to 127. After the initial two hours, the maximum temperature was still more than 60°F below the failure point.

Figure 122. Center column temperatures in interstitial space at measurement point two feet above walk-on deck, test 3

Figure 123. Center column temperatures in interstitial space at measurement point four feet above walk-on deck, test 3
